## Site 174 Ebben Creek

Great Marsh Coastal Wetlands Restoration Plan  
Rapid Technical Assessment Site 174

# Great Marsh Coastal Wetlands Restoration Planning

## Rapid Field Assessment

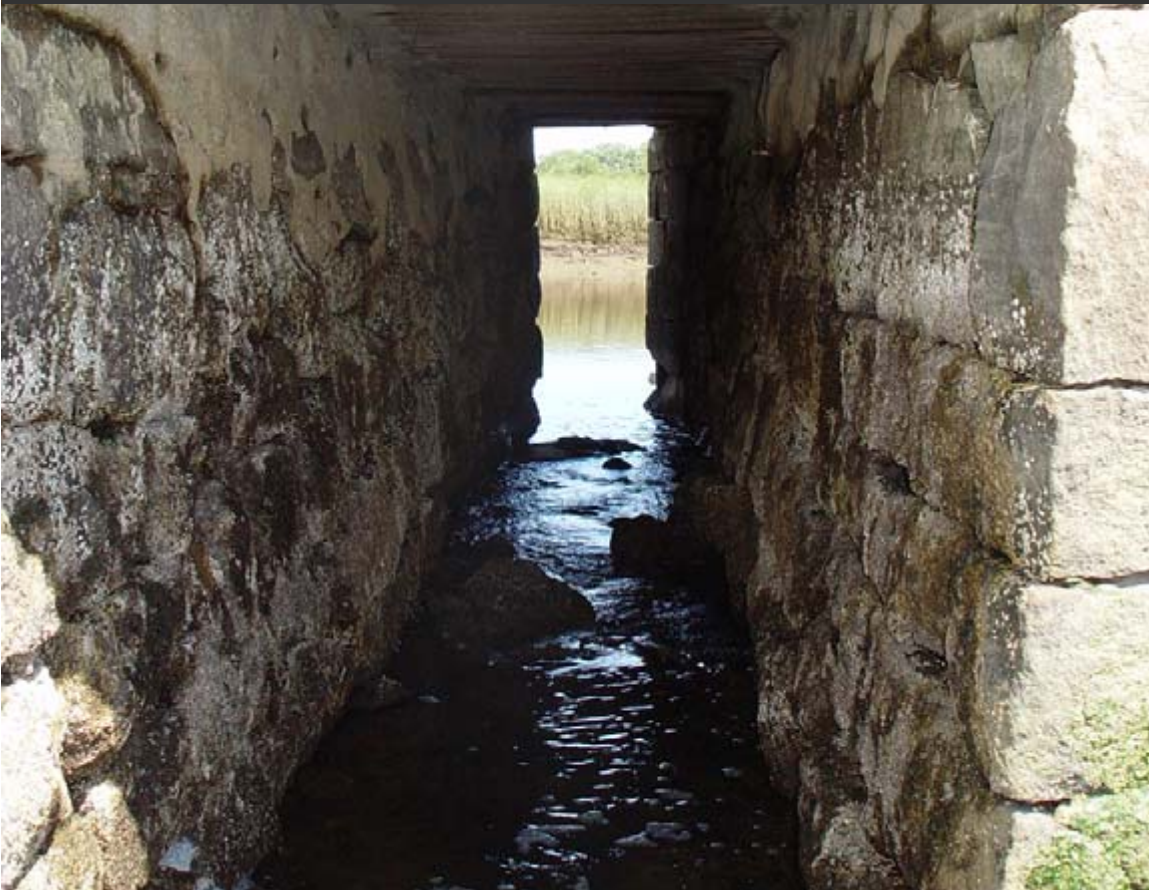
**Photo 6 - Interior of Granite Culvert**

**Structure conditions:** Ebben Creek is conveyed under Route 133 via a 3 ft wide by 7 ft high granite block culvert. The granite blocks are supported by timber lagging and carry a concrete deck supporting the roadway. The upstream and downstream inverts and embankments are protected from scour by riprap. Beyond the riprap protection are significant scour pools. Inside the culvert there is some minor erosion around the timber lagging; however it is not severe enough to affect the structural integrity of the culvert. Overall the culvert is in fair condition and Route 133 is in good condition. The original age of the structure is unknown. The concrete deck was last replaced in 1934. Construction of a sewer line along Route 133 was recently completed and the roadway was repaved. There is approximately 4 ft of cover over the culvert which includes a number of underground utilities. The life expectancy of the culvert is estimated at 15 years. There are no known plans to replace the structure.
